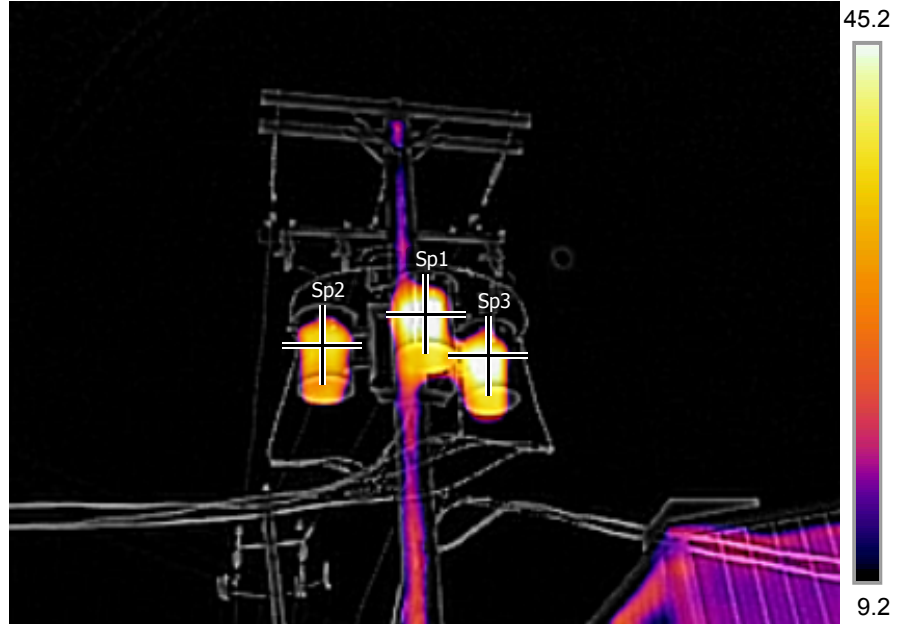
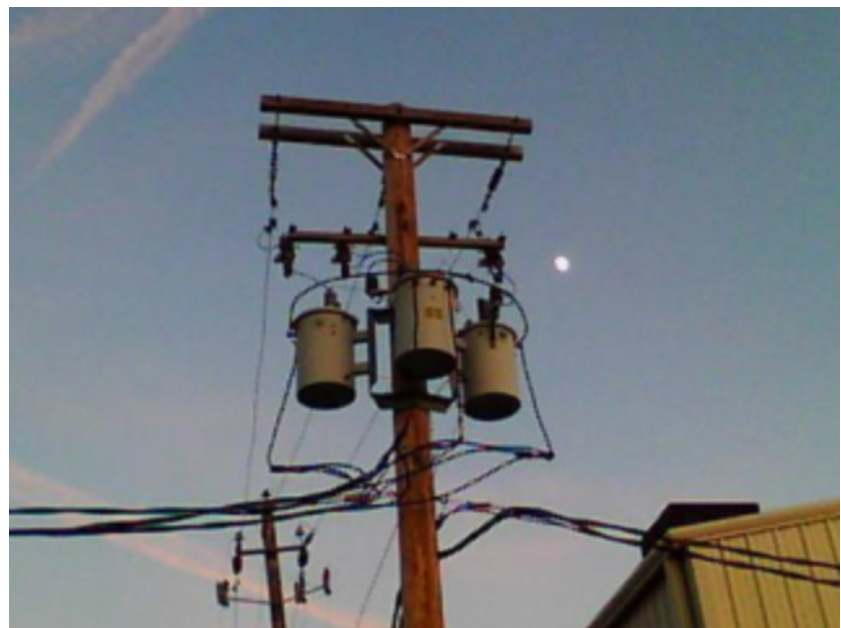
FLIR0042.jpg

Sp1	49.1 °F
Sp2	37.9 °F
Sp3	46.1 °F

Emissivity	0.8
Ref. temp.	29 °F

Temperature Change noted below:

Trans 1 (Sp1)
 Trans 2 (Sp2) 11.2 degrees

Trans 1 (Sp1)
 Trans 3 (Sp3) 2.9 degrees

Trans 2 (Sp2)
 Trans 3 (Sp3) 8.30 degrees

Recommended Action:
 Check load balance on
 Transformer 2 or run diagnostic
 test on Transformer 2.
